BROKEN HILL WATER SUPPLY
UMBERUMBERKA WATERWORKS

SUBMISSION TO
ENGINEERING HERITAGE AUSTRALIA

for an
HISTORICAL ENGINEERING MARKER

October 2008

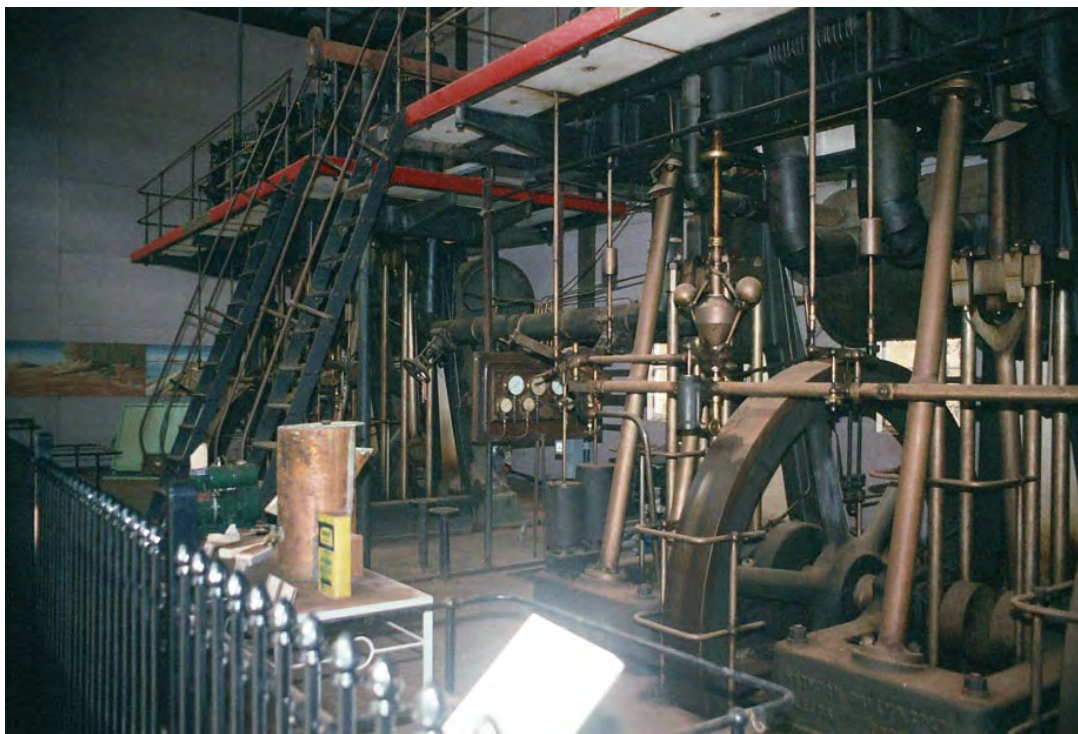
Plate 2. Umberumberka Pumping Station. The two Hathorn Davey triple expansion vertical inverted steam pumping engines.

The Hathorn Davey engines (see **Plates 1,2,3**) are 300 horsepower each, triple expansion, fitted with Corliss valve gear and operated on superheated steam at 175 psi. The cylinder diameters are 16, 28 and 46 inch by 36 inch stroke. The normal operating speed ranged from 13 to 35 rpm. The pumps are located below the engines and are driven from the cross heads by push rods.

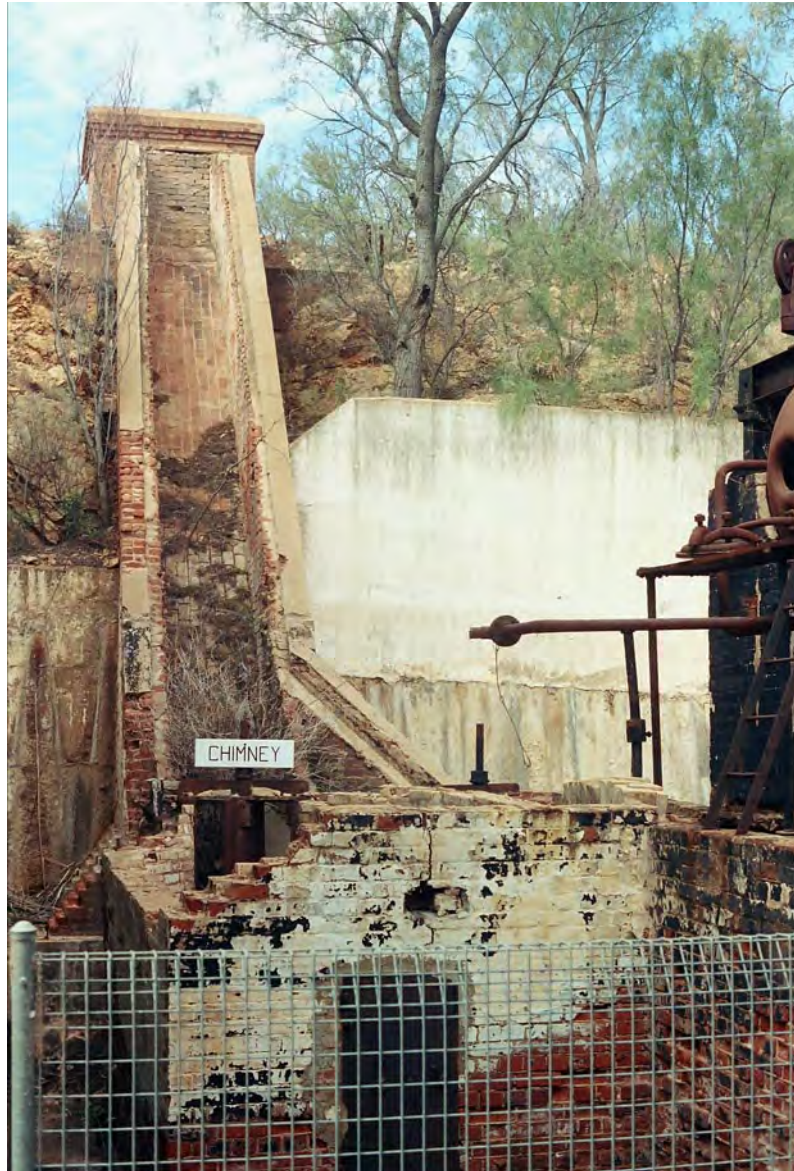
Plate 4. Umberumberka Pumping Station. Flue and Chimney Base behind boilers. The chimney was placed on the escarpment to increase its effective height.

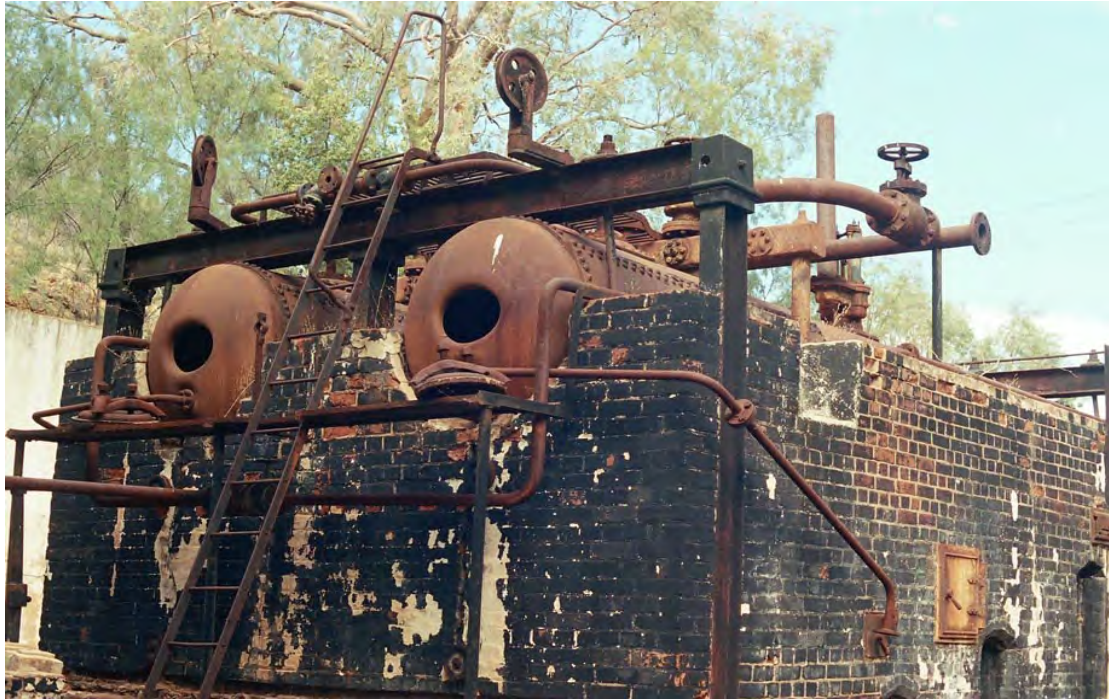
Plate 5. Umberumberka Pumping Station. Two Babcock and Wilcox water tube boilers which supplied steam to the Hathorn Davey pumping engines.

The two coal-fired boilers are Babcock & Wilcox 350 horsepower water tube single drum type with superheaters and rotative chain-grate mechanical stokers (see **Plate 5**). The heating surface area is 1650 square feet per boiler and they are rated at 175 psi.

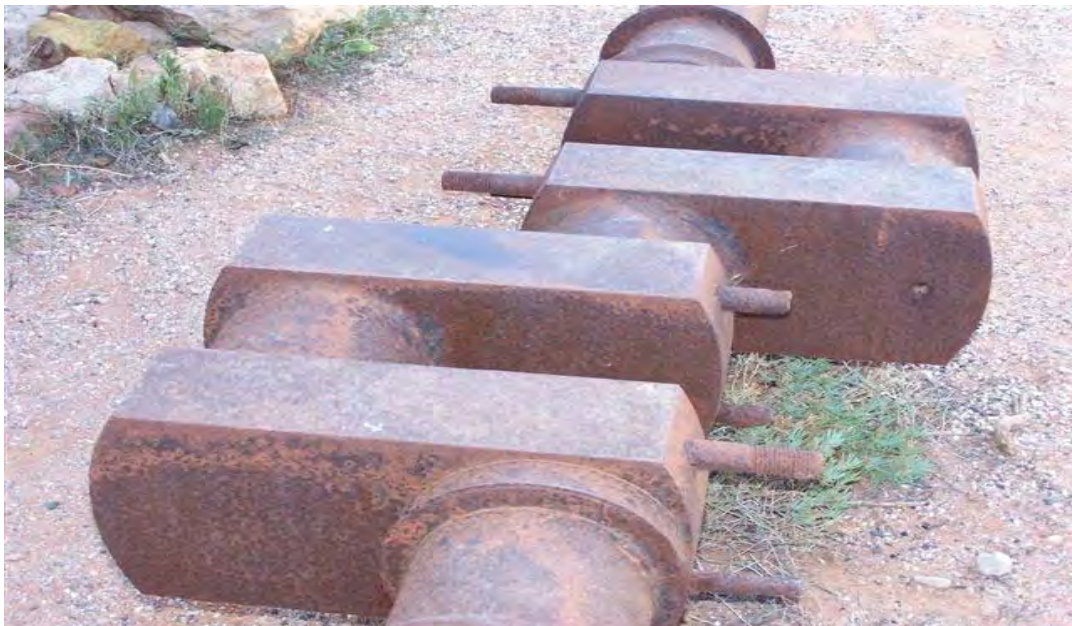
Plate 6. Crankshaft believed to be from one of the Wolf pumping engines originally installed at Umberumberka Pumping Station in 1915. The crankshaft is located in front of a shop in Silverton township a few kilometers from the pumping station. This may be all that remains of the original engines.

The Wolf engines were apparently scrapped after removal. The actual date is unknown. A crankshaft reputed to be a part of one of these engines is located outside a shop called The Coin Carvery at Silverton (see **Plate 6**). Whilst it has not been possible to verify that the claim is correct the crankshaft is from a two cylinder engine and its size is generally consistent with a 250 horsepower engine. The shop owner also suggests that there may be “a few more fragments” at Umberumberka.

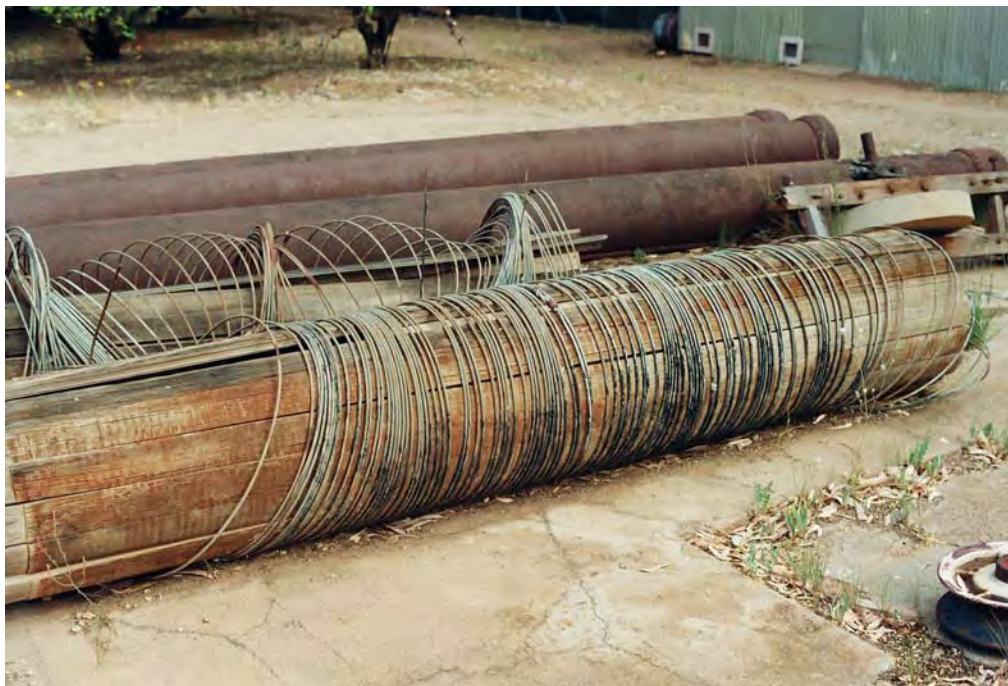
Plate 8. Sections of woodstave pipeline removed from the Umberumberka to Broken Hill gravity pipeline installed in 1915. The wires wrapped around the timber section contain the internal pressure.

The wooden stave pipe construction was used extensively in the early days of water supply pipelines where wood was available. The pipe consisted of a number of wooden planks running parallel to the centre line of the pipe and wrapped with a continuous steel wire binding to contain the pressure. The joints in the wood were offset and water proofing was achieved by careful fitting and the liberal use of pitch coating. The pipes were usually run above ground or in a large open trench on concrete or brick support stools to avoid contact with surrounding backfill soil and subsequent rotting of the timber. The wood stave pipelines were of relatively low water pressure capability and were inherently high maintenance.

Samples of the original pipe are on display at the Umberumberka Pumping Station (see **Plate 8**).

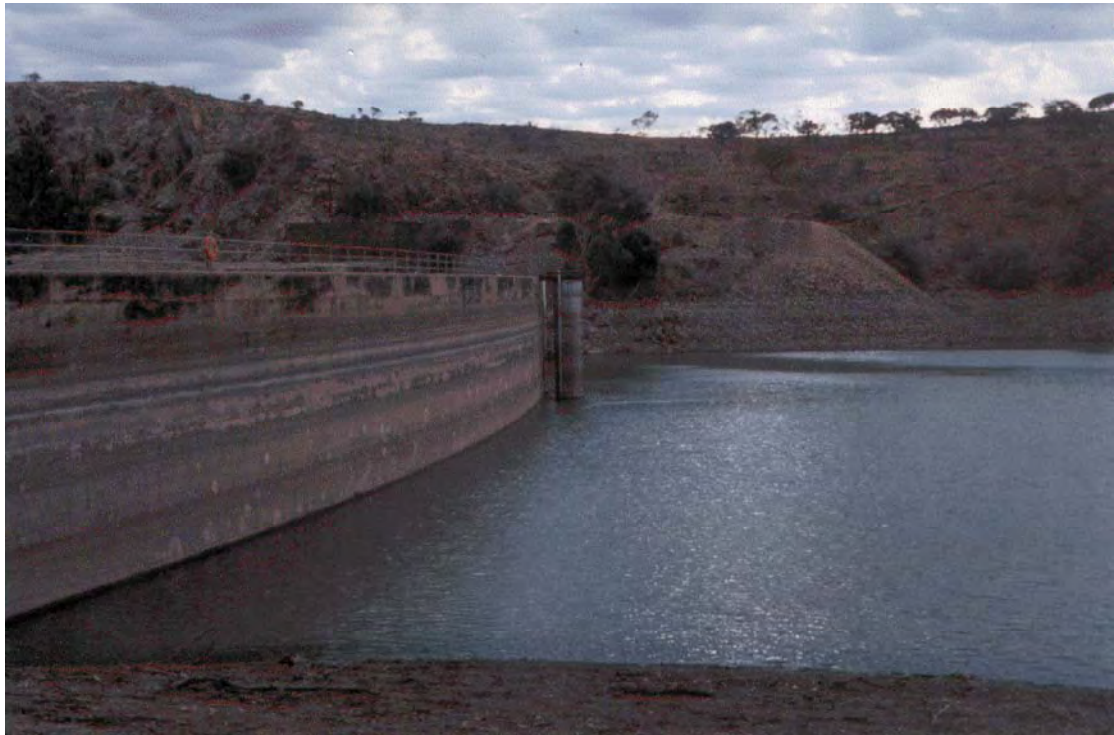
Plate 9. Umberumberka Reservoir from the public viewing point looking at the upstream side of the dam wall. This photograph was taken in September 2002 when the water level was quite low and not far above the silt level.

The concrete gravity dam (see **Plates 9 & 10**) is 85 feet high and extends 50 feet below the creek bed into bedrock. The dam is 680 feet long at the crest with a

The original capacity of the dam was 13.2 Megalitres but siltation had reduced this to 7.8 Megalitres by 1974. In fact by 1985 the silt against the back of the main wall had reached RL 14.1 metres compared to a Top Water Level of RL23.4 metres leaving a water depth of only 9.3 metres when the dam was full.
